# Fire Extinguisher Explosion on DZ 28

Friday Nightshift 7<sup>th</sup> May 2010

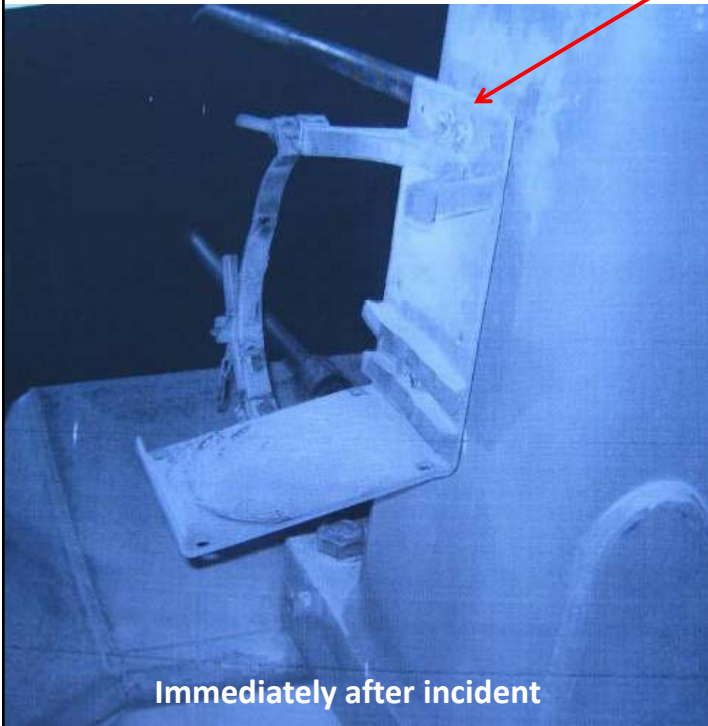
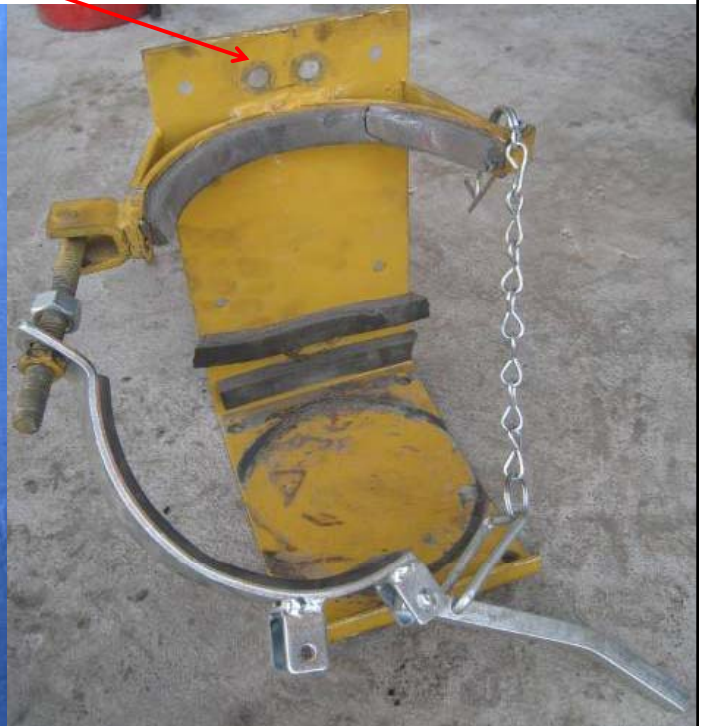
# Actual Bracket Involved

Arrows point to bolt location

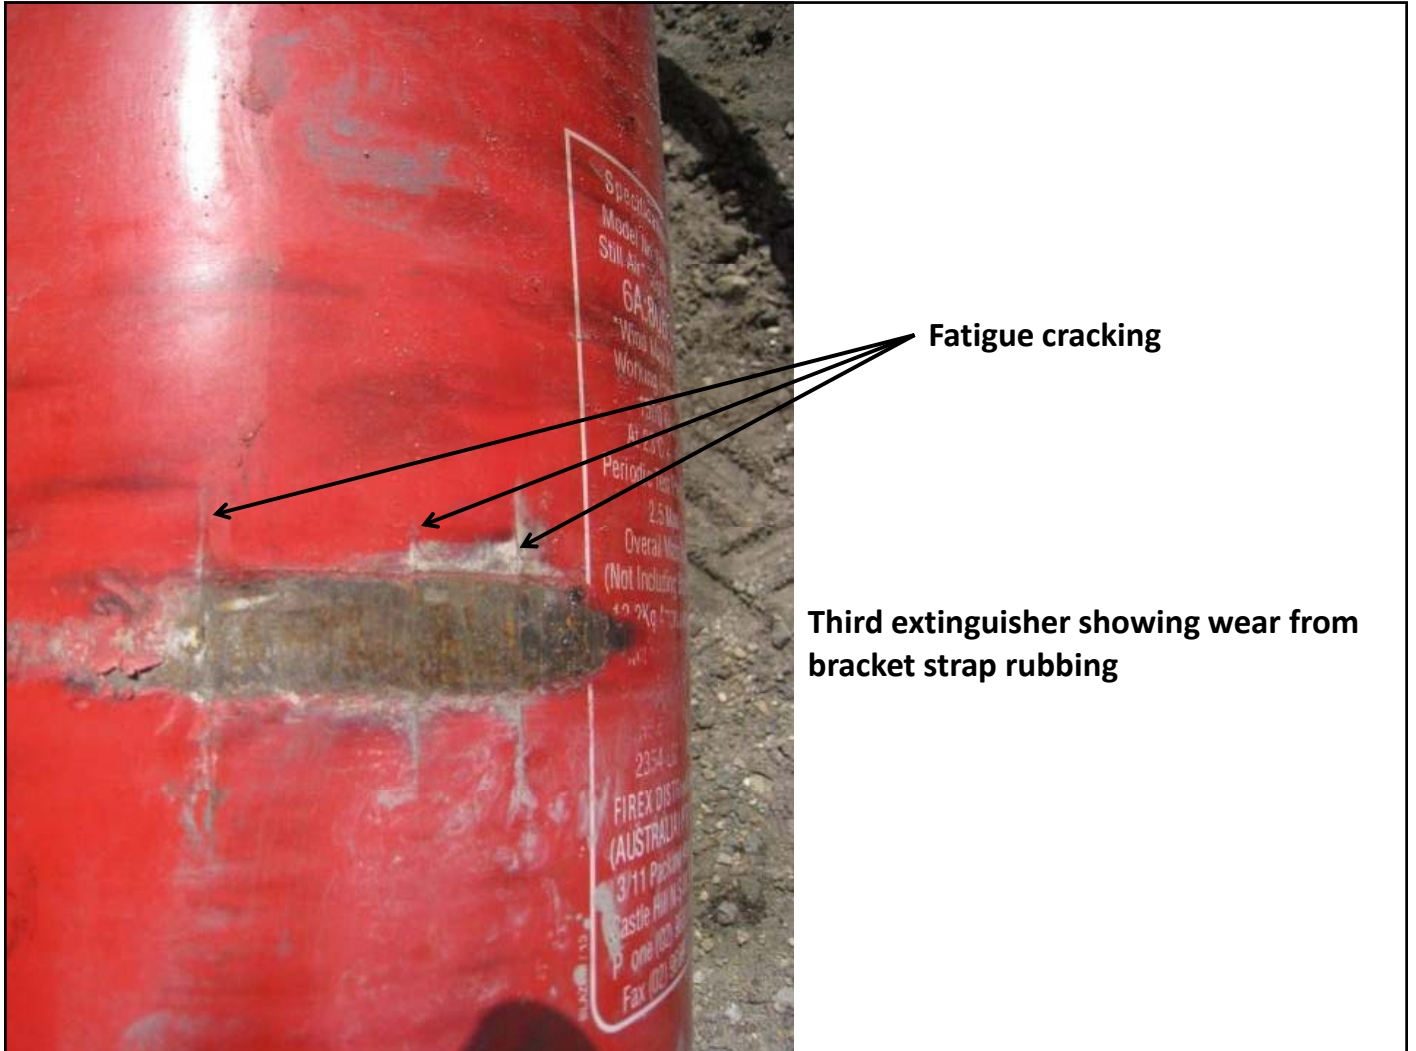
**Fatigue cracking**

**Third extinguisher showing wear from bracket strap rubbing**

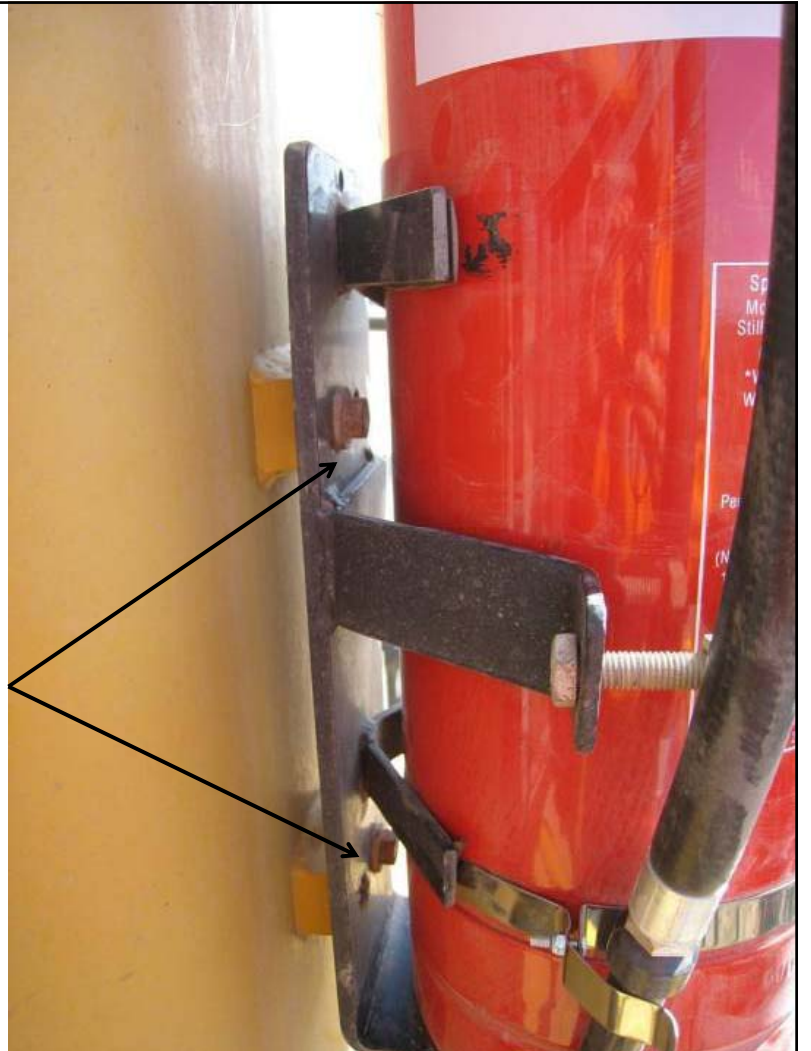
Alternate bracket design showing adequate gap between bolt heads and extinguisher
